NJPDES Permit NJ0001511
Program Interest ID #46318
Inspection Report & NOV Response

**Bayway Refinery Response to
January 3, 2020 Compliance Evaluation Inspection (CEI)
Report & December 26, 2019 Notice of Violation (NOV)
NJPDES Surface Water Discharge Permit NJ0001511: Program Interest ID #46318**

January 3, 2020 CEI Report Deficiency Nos. 1-3

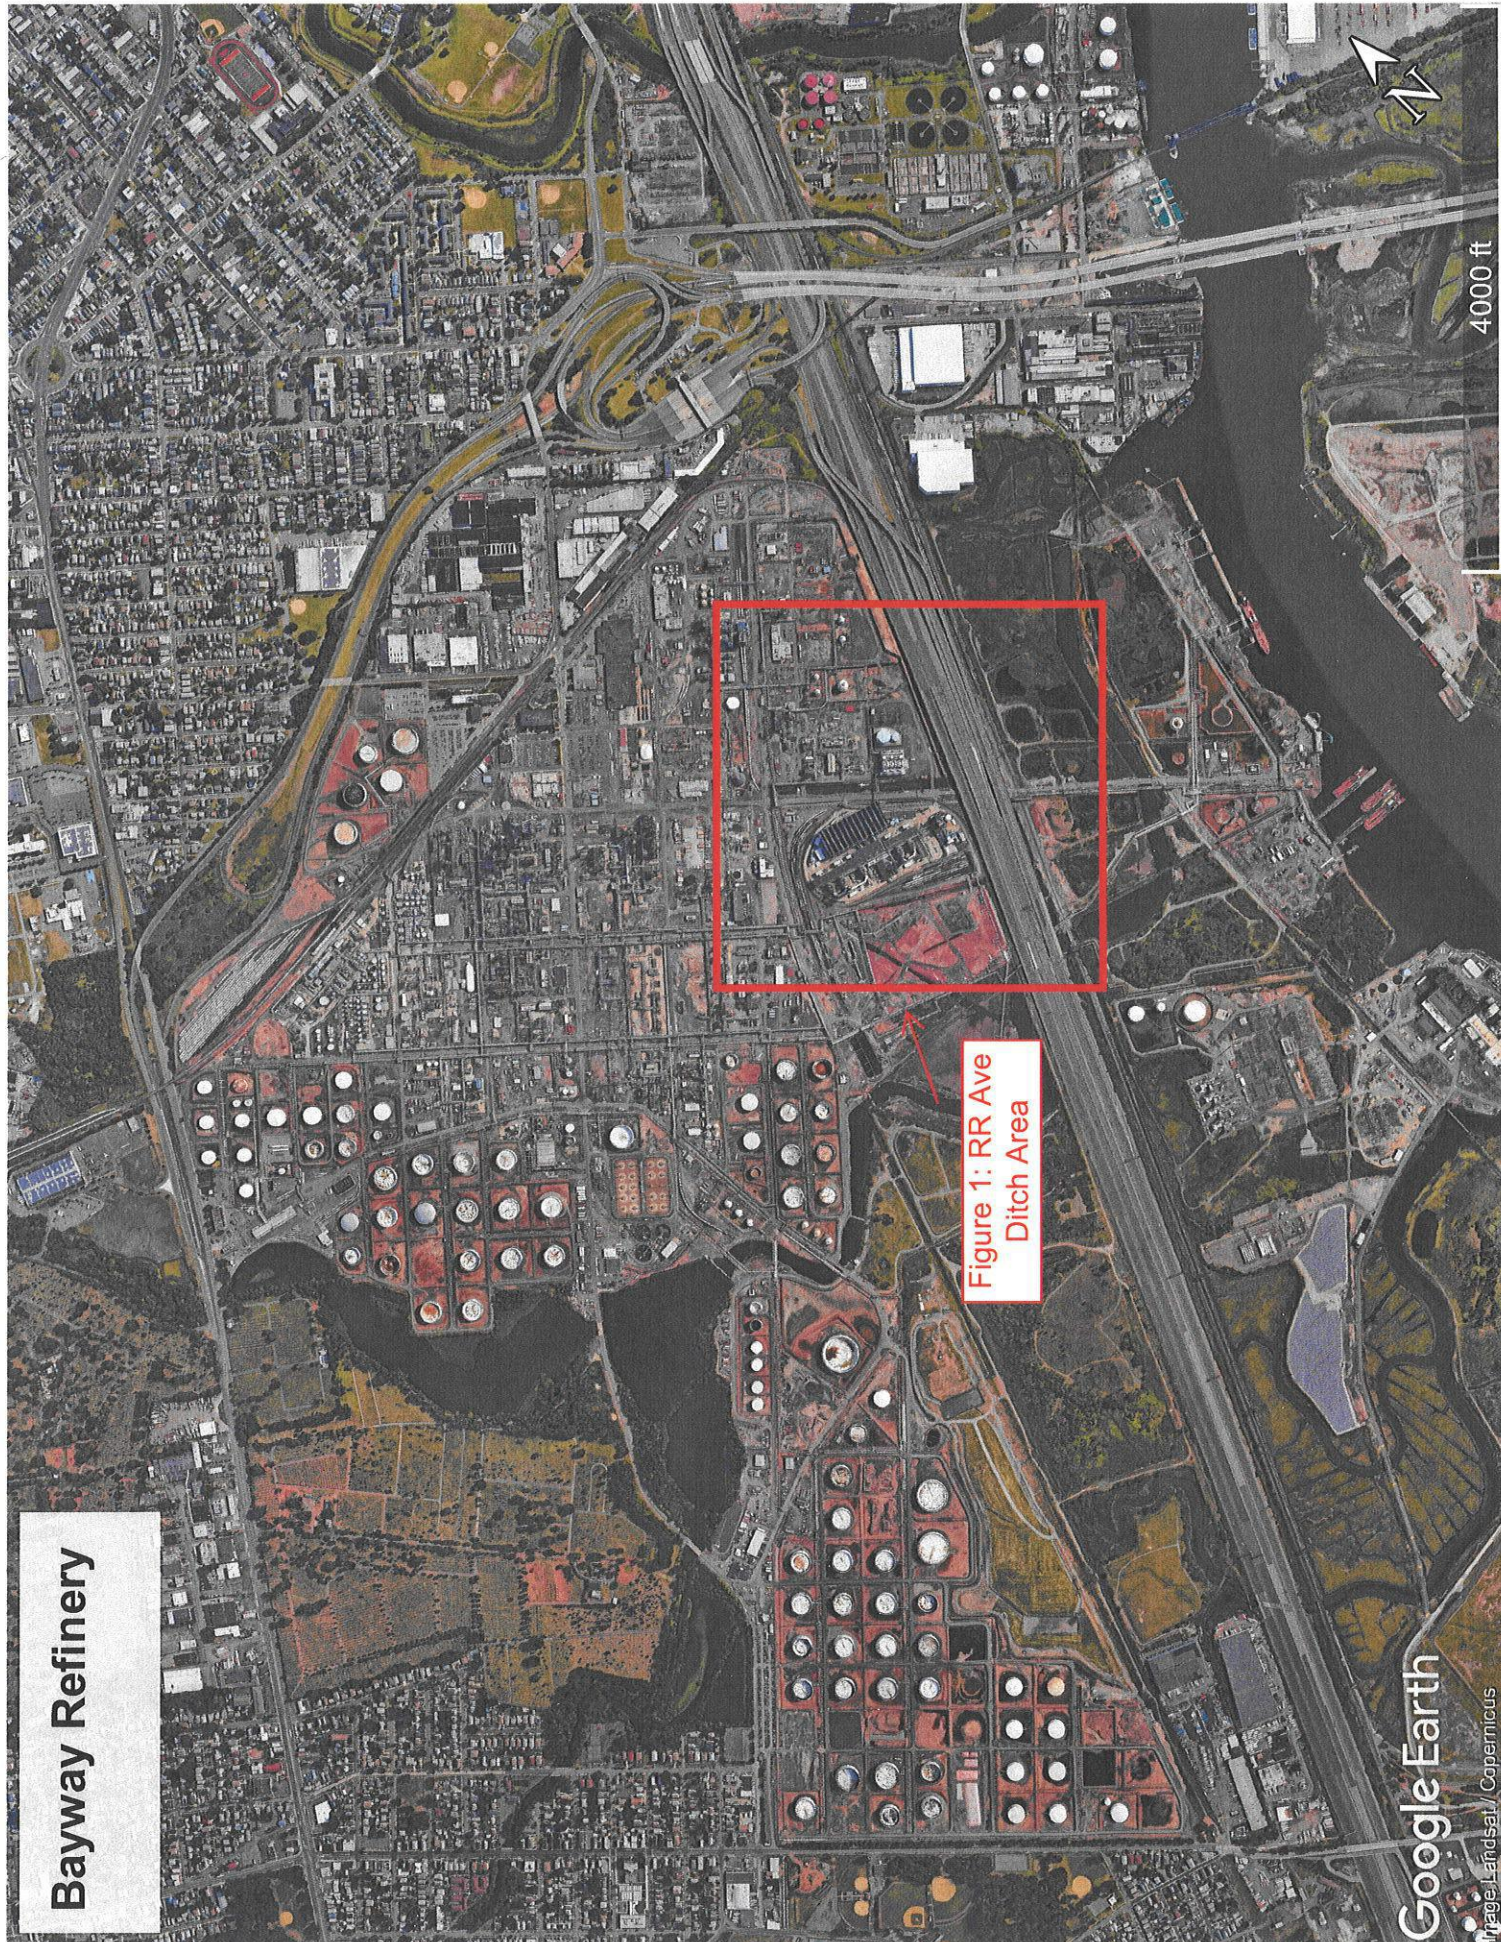
Figure 1: RR Ave
Ditch Area

The DSN 005A discharge monitoring point is located within Railroad Avenue Ditch upstream of additional floating material containment facilities. It was selected for monitoring for several reasons, including safety (existing hand rails, no need to walk on stone or sample from sloped banks along the ditch), easy access to sample the center of the ditch flow, and upstream of rain downspouts that discharge NJ Turnpike runoff into Railroad Avenue Ditch. It's selection for monitoring fully recognized that there were additional downstream containment facilities in Railroad Avenue Ditch, but NJDEP preferred to stay upstream of the NJ Turnpike downspouts; this became irrelevant during the permitting process when NJDEP decided that DSN 005A should only be sampled during dry weather. The Polypropylene Separator cannot discharge directly into Morses Creek and its discharge must first flow through the Railroad Avenue Ditch and DSN 005A. Figure 1 shows the resin separator, Railroad Avenue Ditch, the observed containment boom within Railroad Avenue Ditch underneath the NJ Turnpike, the DSN 005A

monitoring point, the Railroad Avenue Ditch dam, and the Railroad Avenue discharge point into Morses Creek, as described above.

- Railroad Avenue Ditch continues for over thousand feet after the containment boom where the plastic residual and scum was photographed within the containment boom under the NJ Turnpike overpass by NJDEP on June 20 for recovery by vacuum trucks, which were actively skimming the contained floating material at the time. This boom is not located within a receiving waterbody. DSN 005A sampling point is located downstream of the cited collection point, as are additional containment facilities.

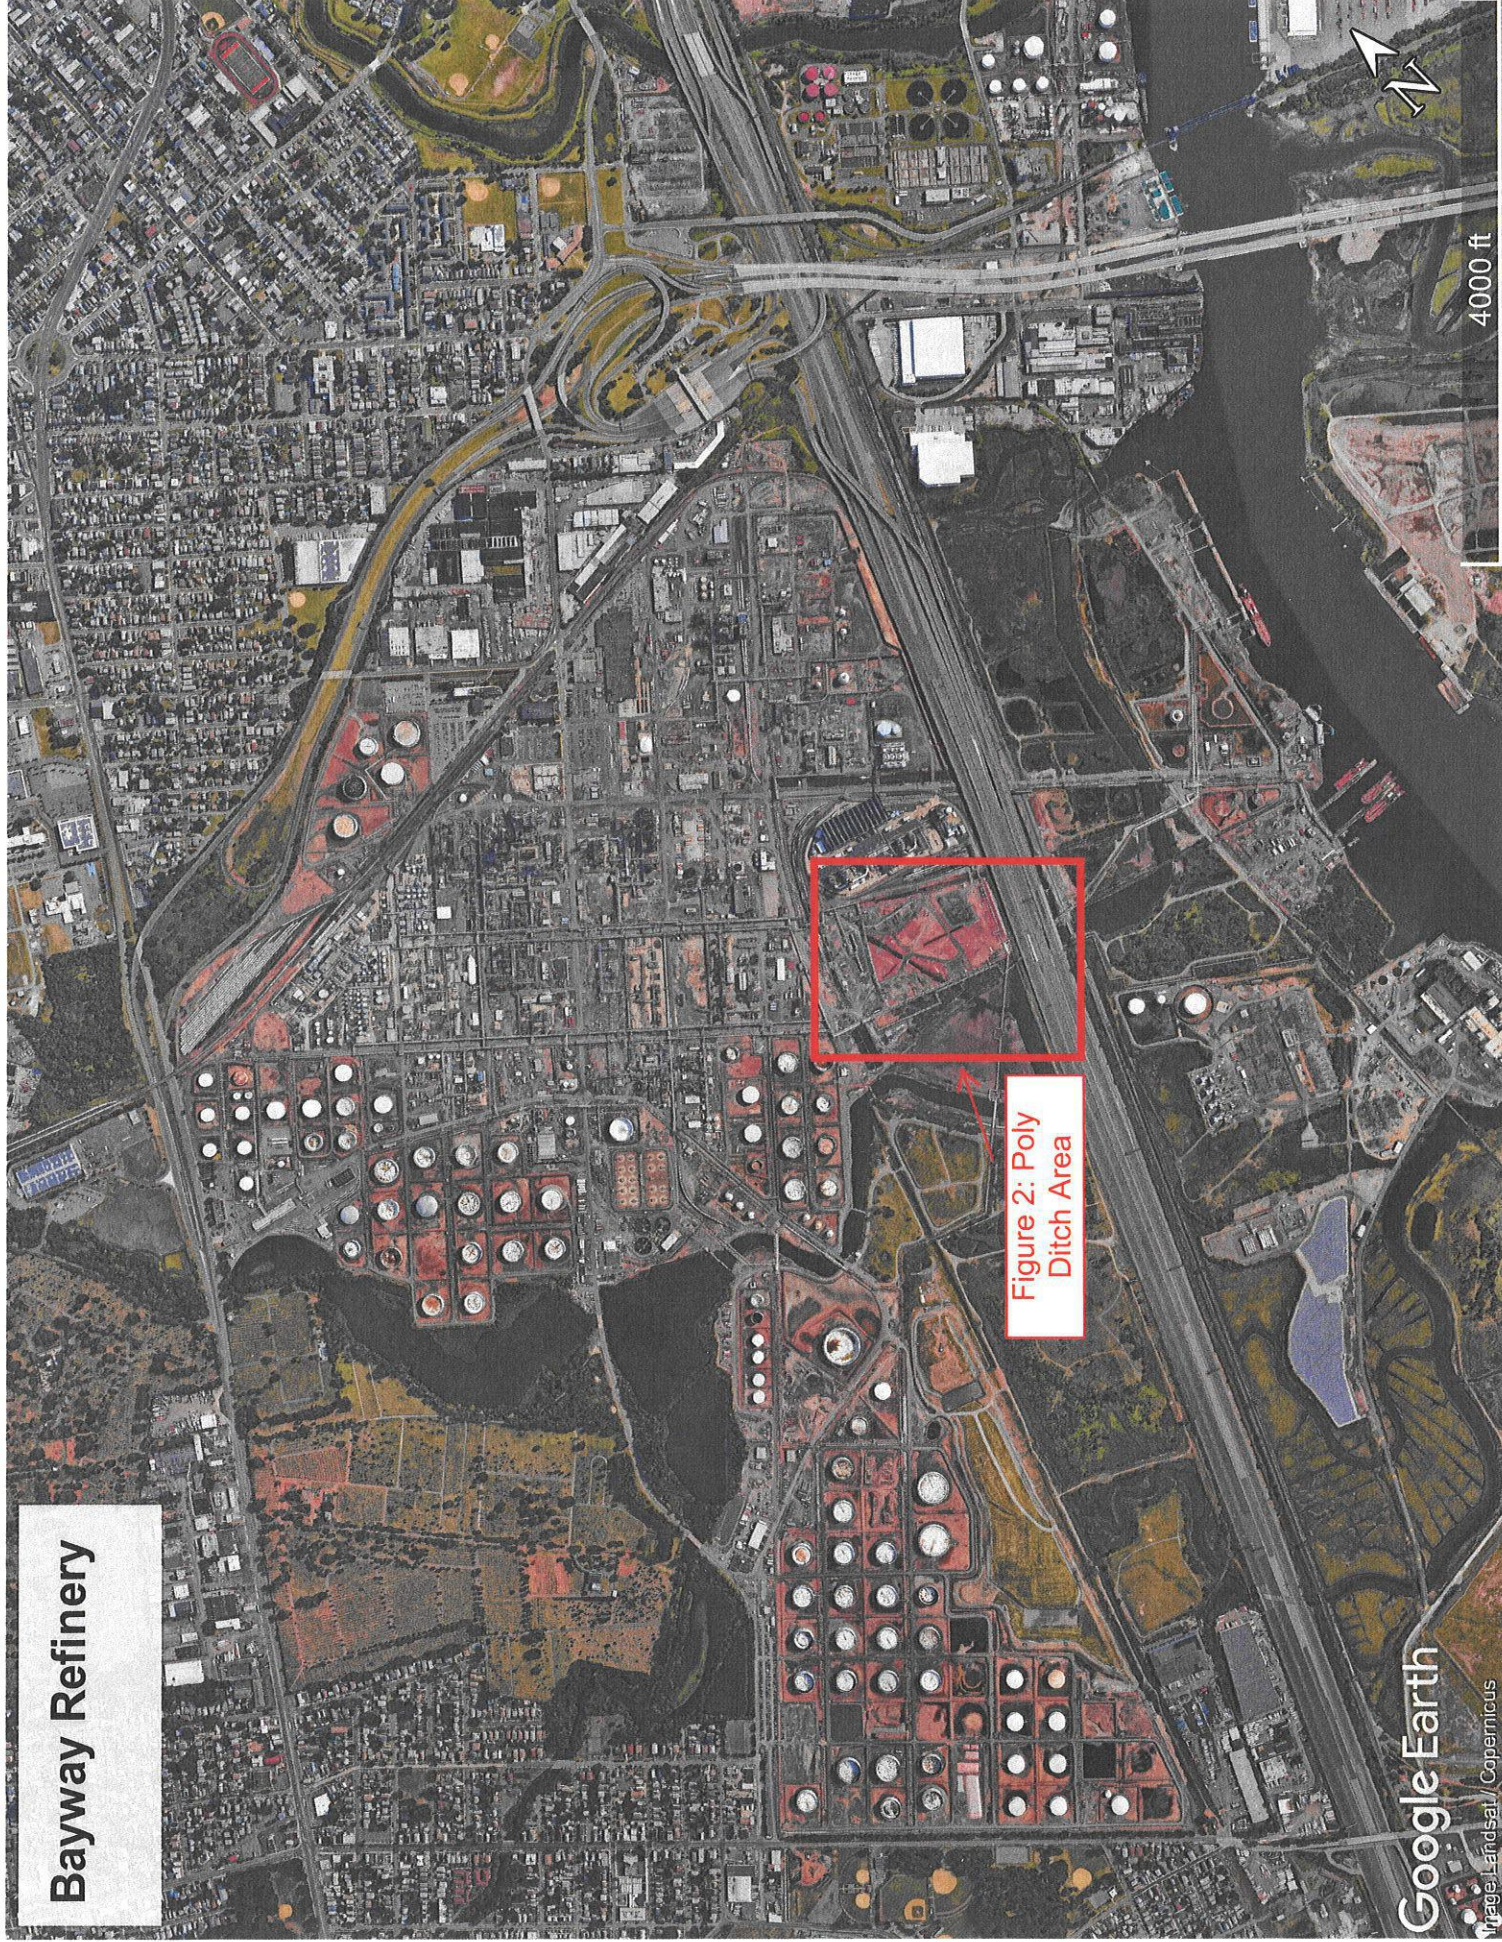
Figure 2: Poly
Ditch Area

DSN 004A is known onsite as Poly Ditch. Similar to Tremley Ditch and Railroad Avenue Ditch, Poly Ditch is a manmade ditch constructed to convey refinery discharges to Morses Creek. Poly Ditch is not a receiving waterbody. Poly Ditch starts at the outlet of a culvert which discharges commingled stormwater and cooling water into Poly Ditch. Similar to Tremley Ditch and Railroad Avenue Ditch, the Poly Ditch has a low level overflow dam over one thousand feet upstream of its discharge into Morses Creek. The dam maintains a constant water level in the upstream portion of the ditch allowing two containment booms to capture sheen and other floating material that enters the Poly Ditch (e.g. from equipment leaks or road run-off draining into the Poly Ditch). The dam and spill booms together are a significant BMP that supplements other BMPs. The dam and booms were specifically installed to reduce the chance of oil and other floating material from spills, leaks and stormwater runoff from entering Morses Creek. Similar to Tremley Ditch and Railroad Avenue Ditch, Poly Ditch is not a receiving waterbody, it is a conveyance. Figure 2 shows Poly Ditch, the dam and spill booms within Poly Ditch, and the Poly Ditch discharge point into Morses Creek, as described above.

The DSN 004A discharge monitoring point is located at the sewer outlet into Poly Ditch upstream of the two containment booms and associated overflow dam. It was selected for monitoring for several reasons, including safety (existing hand rails, no need to walk on stone or sample from sloped banks), easy access to sample the center of the ditch flow, and being located outside of the butane and propane storage area that Poly Ditch runs through, which requires gas testing by a process operator before entry to ensure safe conditions. Selection of this point for monitoring fully recognized the downstream containment facilities in Poly Ditch.

Poly Ditch continues for over one thousand feet after the first containment boom where the floating material was observed contained on June 20. The floating material was predominantly biological scum being released in response to the ongoing molluscicide treatment. Note that biological scum can have a dull sheen that is similar in appearance to dull sheen from oil, depending on the oil source and quantity. Regarding the light sheen observed on October 29, we again note that the sheen was contained within the first containment boom within Poly Ditch. We also note that the amount of material collected at the containment boom on both days was very small relative to the over 10 million gallons of day of continuous flow into Poly Ditch, that there was no ongoing observable sheen discharging from the upstream sewer into Poly Ditch on either day, no sheen was observed past the first boom, and that Bayway verified that there were no equipment oil leaks into Poly Ditch on either day. The Poly Ditch receives runoff from an area that includes paved surfaces, streets and parking areas. With some rain preceding both inspection days, the most likely source of the nominal amount of sheen observed would have been road runoff and/or biological scum resulting from biocide treatment, which is generally conducted daily using bleach (bleach treatment is separate from the molluscicide treatment). Regardless of the source of the floating material, the containment boom was functioning as designed, allowing subsequent recovery by vacuum truck. The need for vacuum trucks is determined through normal operator rounds, which include checking the spill booms in Poly Ditch at least once per shift. This floating material containment system is one of several BMPs already in place and proven to be effective as observed by NJDEP and USEPA.
